Data Update for Thompson Island, Boston Harbor, MA July 2006

Monthly Data Summary for July 2006

This update summarizes the monthly data results for the Thompson Island monitoring site in Boston Harbor, MA, at 42° 18' 56" N, 71° 0' 40" W (NAD 83). More information on the sensors and site can be found at http://www.ceere.org/rerl/rerl_resourcedata.html.

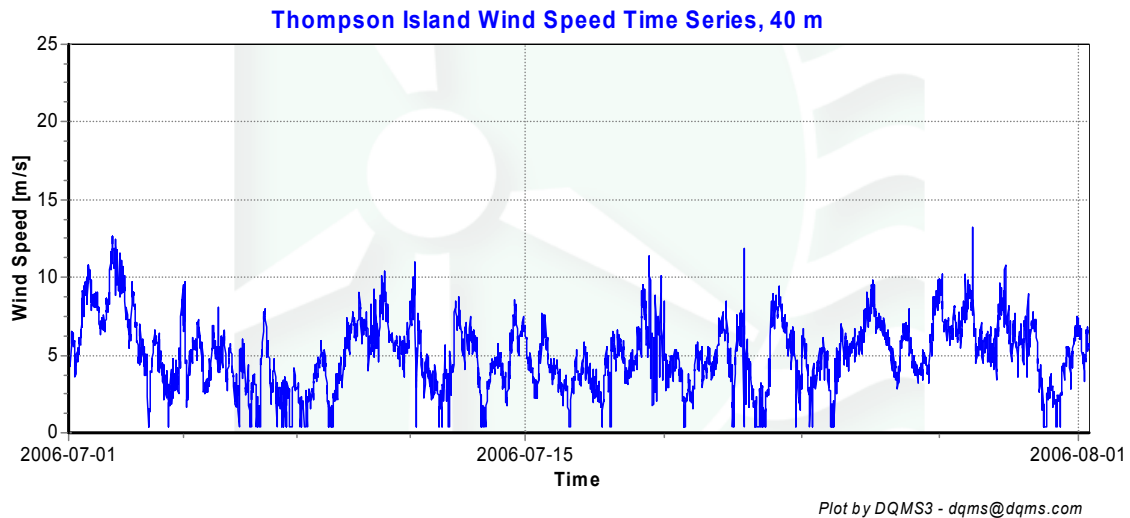
Seen below is a graph of wind speed at Thompson Island for the month of July 2006, at the highest anemometer height of 40 m.
