Data Update for Thompson Island, Boston Harbor, MA August 2008

Prepared for
Massachusetts Technology Collaborative
75 North Drive, Westborough, MA 01581

Monthly Data Summary for August 2008

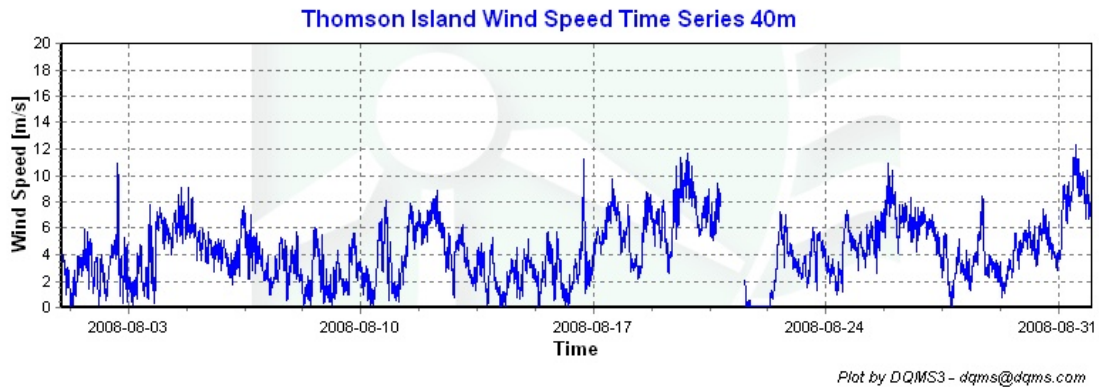
Seen below is a graph of wind speed at Thomson Island for the month of August 2008, at the highest anemometer height of 40 m.
